Flooding and geomorphic evolution of modern floodplain – case study of the Danube river downstream the Devínska brána gate

IAG Regional Conference on Geomorphology „Landslides, Floods and Global Environmental Change in Mountain Regions“

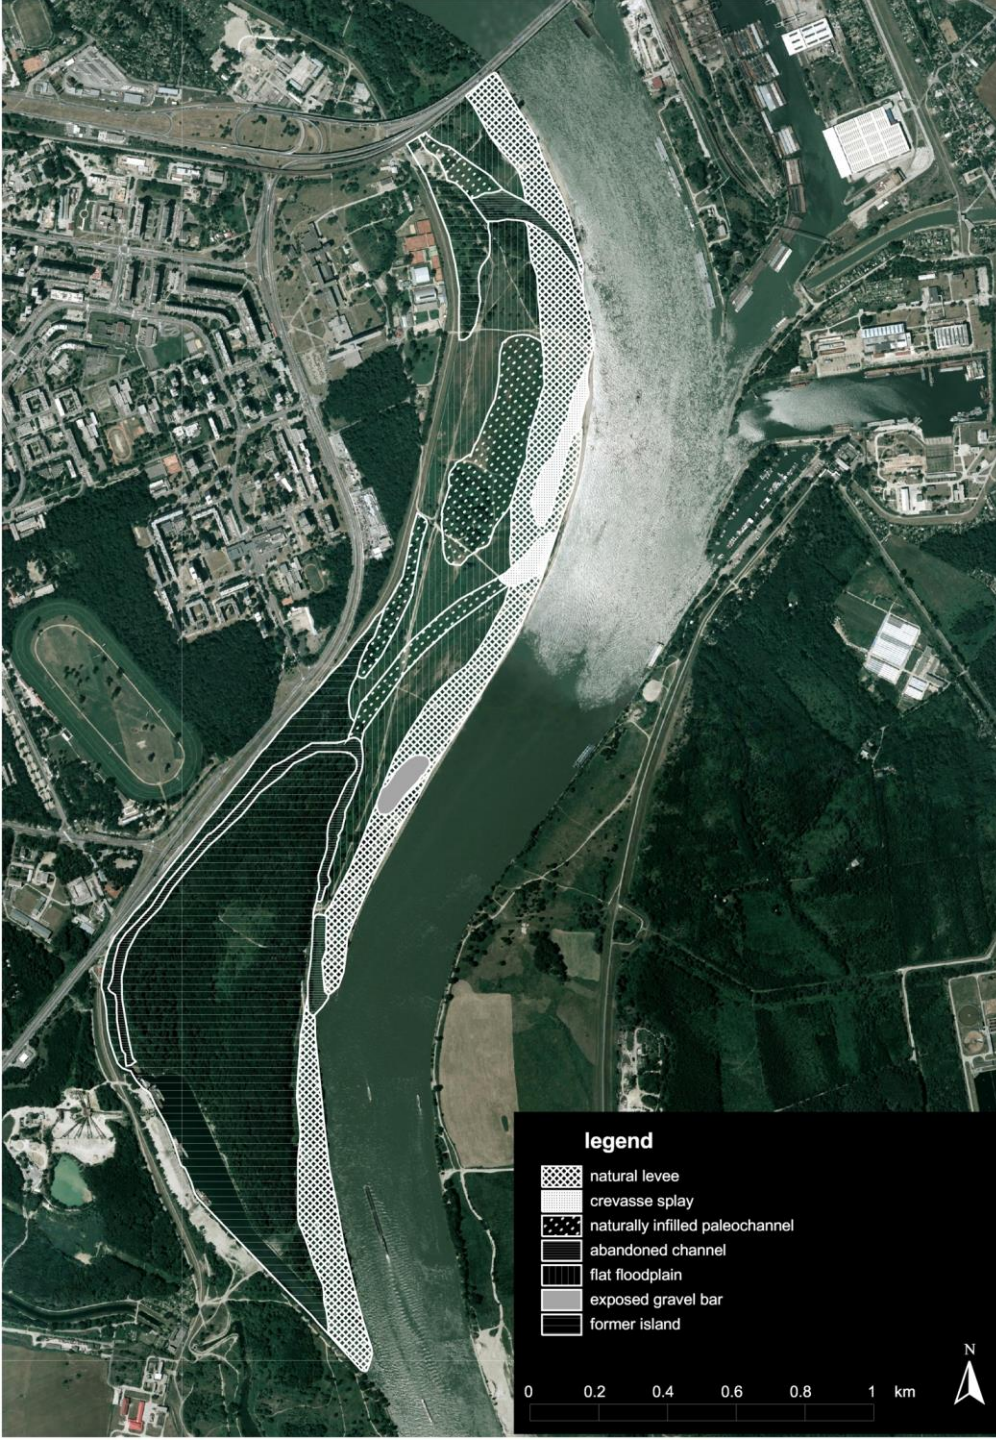
landforms

- **floodplain landform units – geology and morphology**

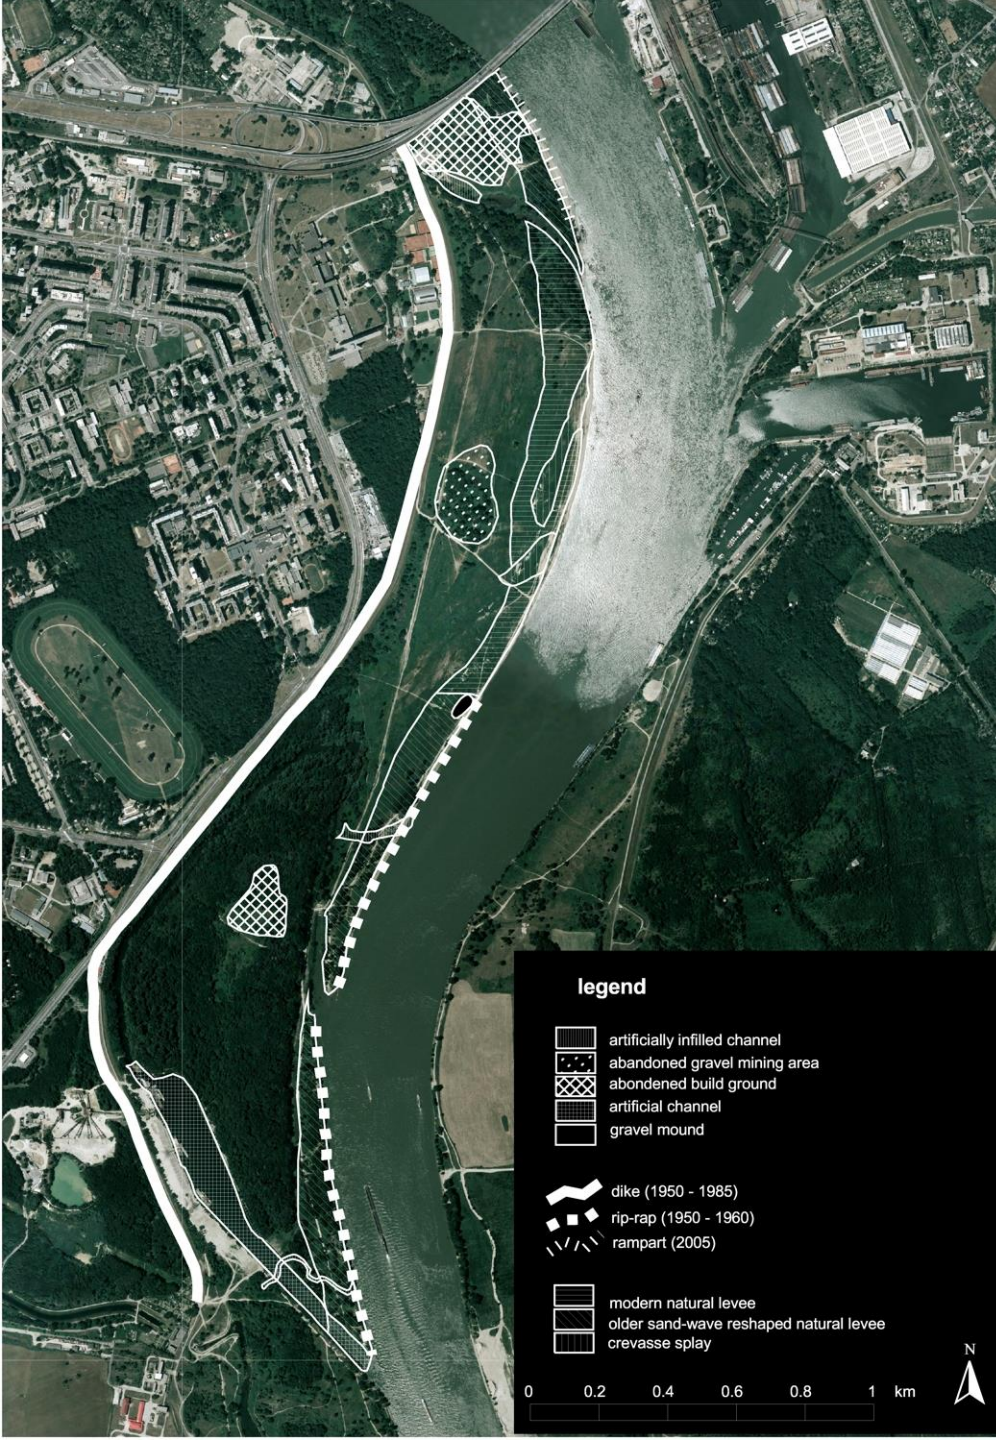
modern landform changes

artificially infilled channel

abandoned gravel mining area

abandoned build ground

artificial channel

gravel mound

dike (1950 - 1985)

rip-rap (1950 - 1960)

rampart (2005)

modern natural levee

older sand-wave reshaped natural levee

crevasse splay

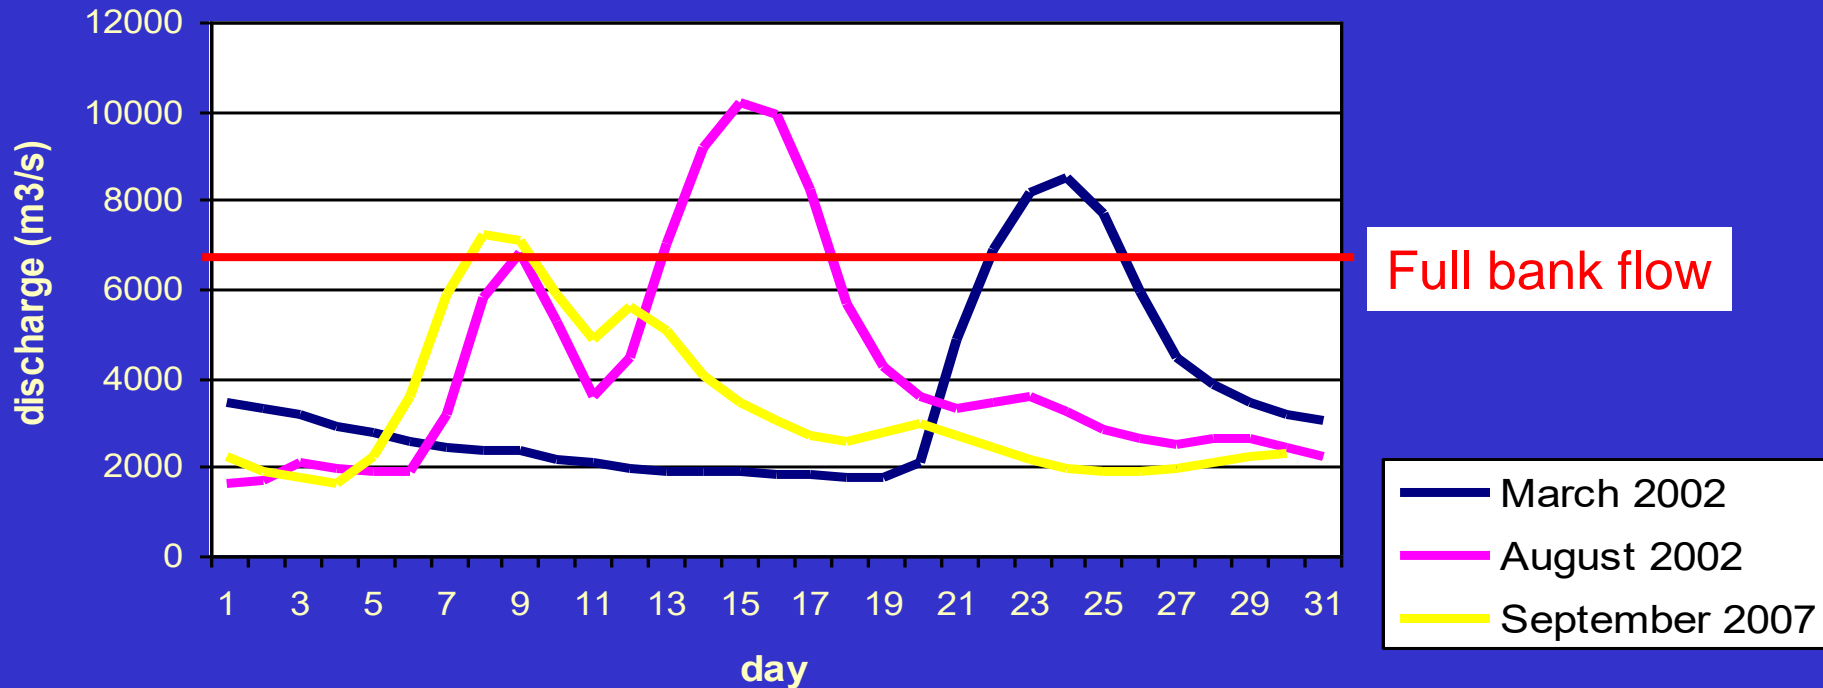
analysed floods

**Mean daily discharge of the Danube river in Bratislava
(March and August 2002; September 2007)**

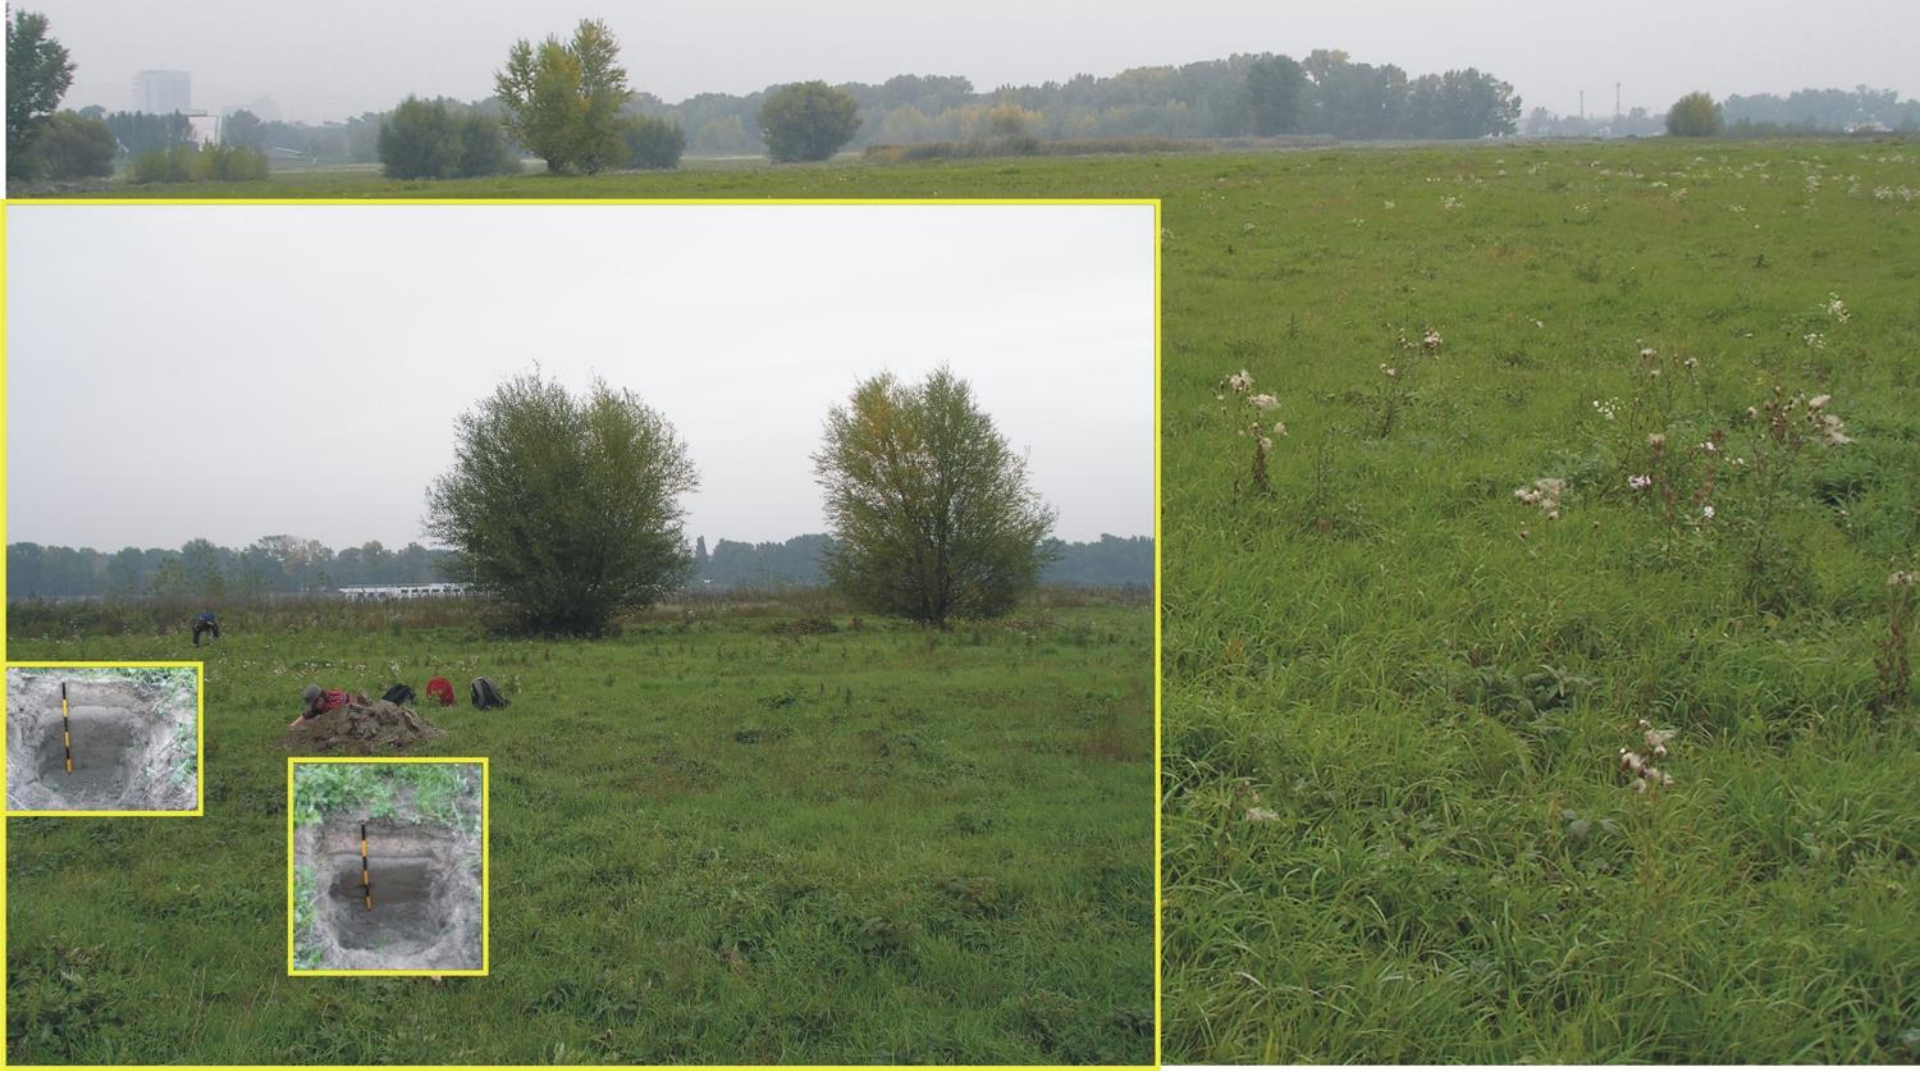
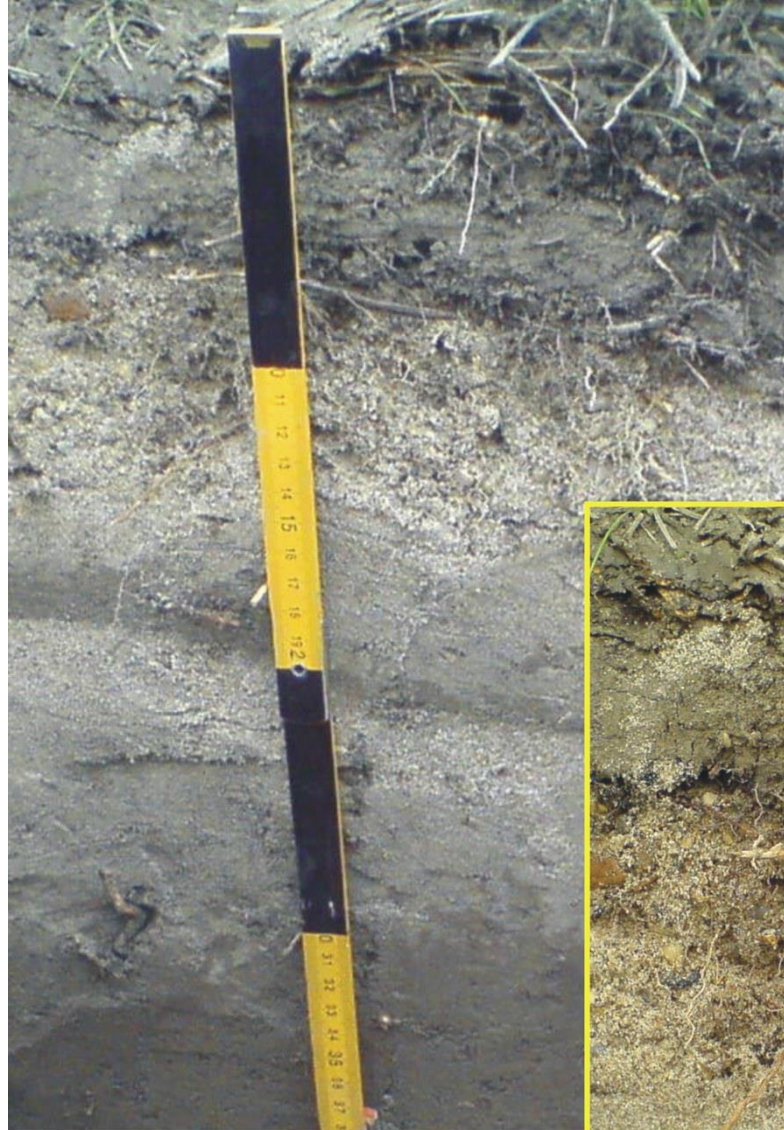
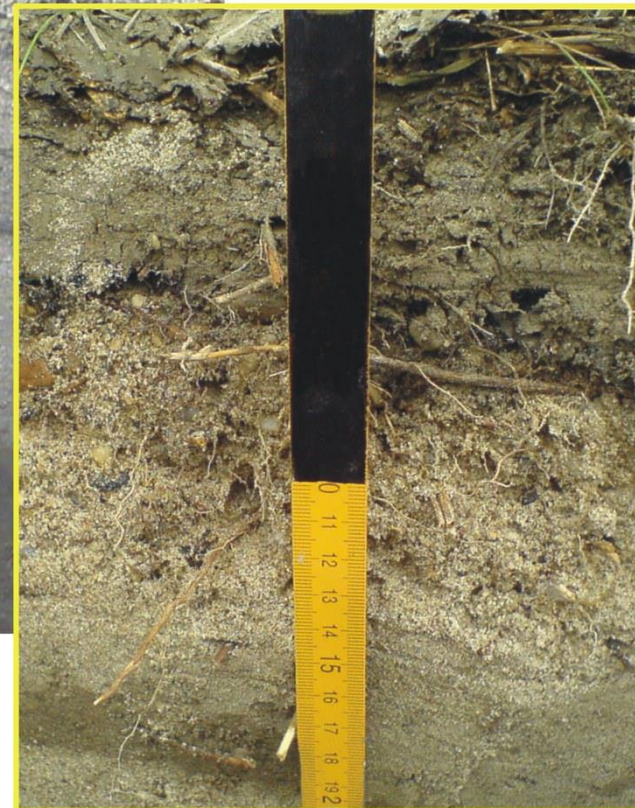
Levee structure

- **flood phases – rising, culmination, fall**
- **complete flood record – set of three layers**
- **three unit cyclothem – fine (mud) – coarse (sand) – fine (mud)**

**Sandy cover lithofacial structure
on the roof of natural levee**

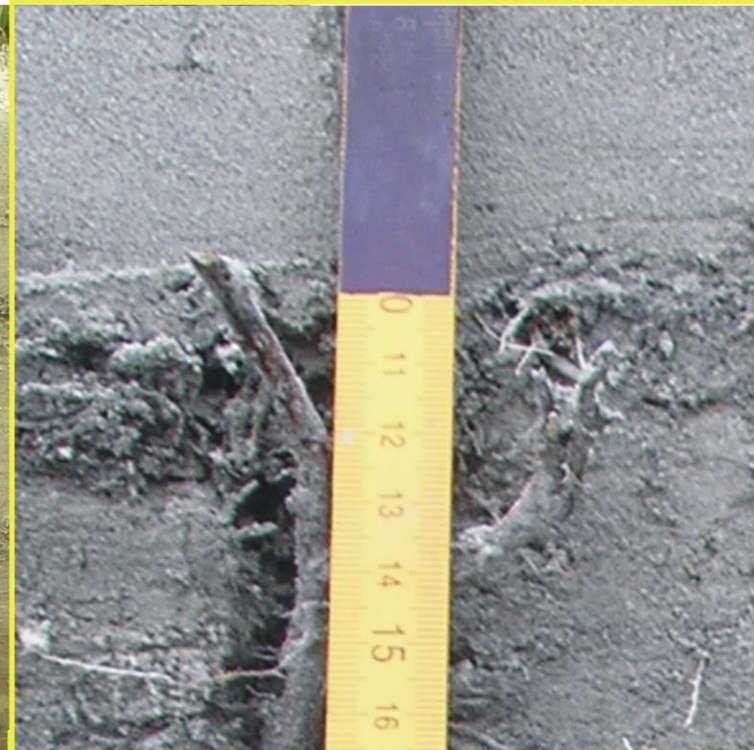
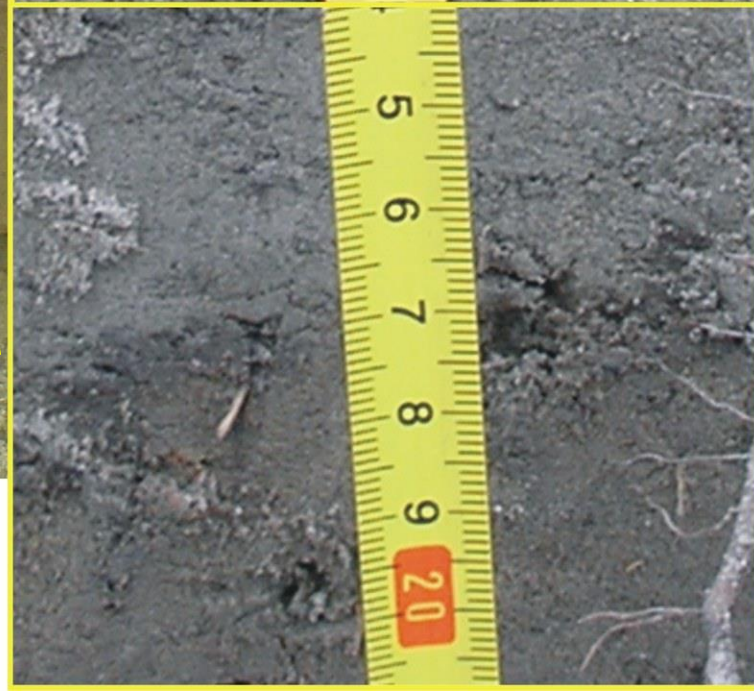
Bank structure

Bank lithofacial structure

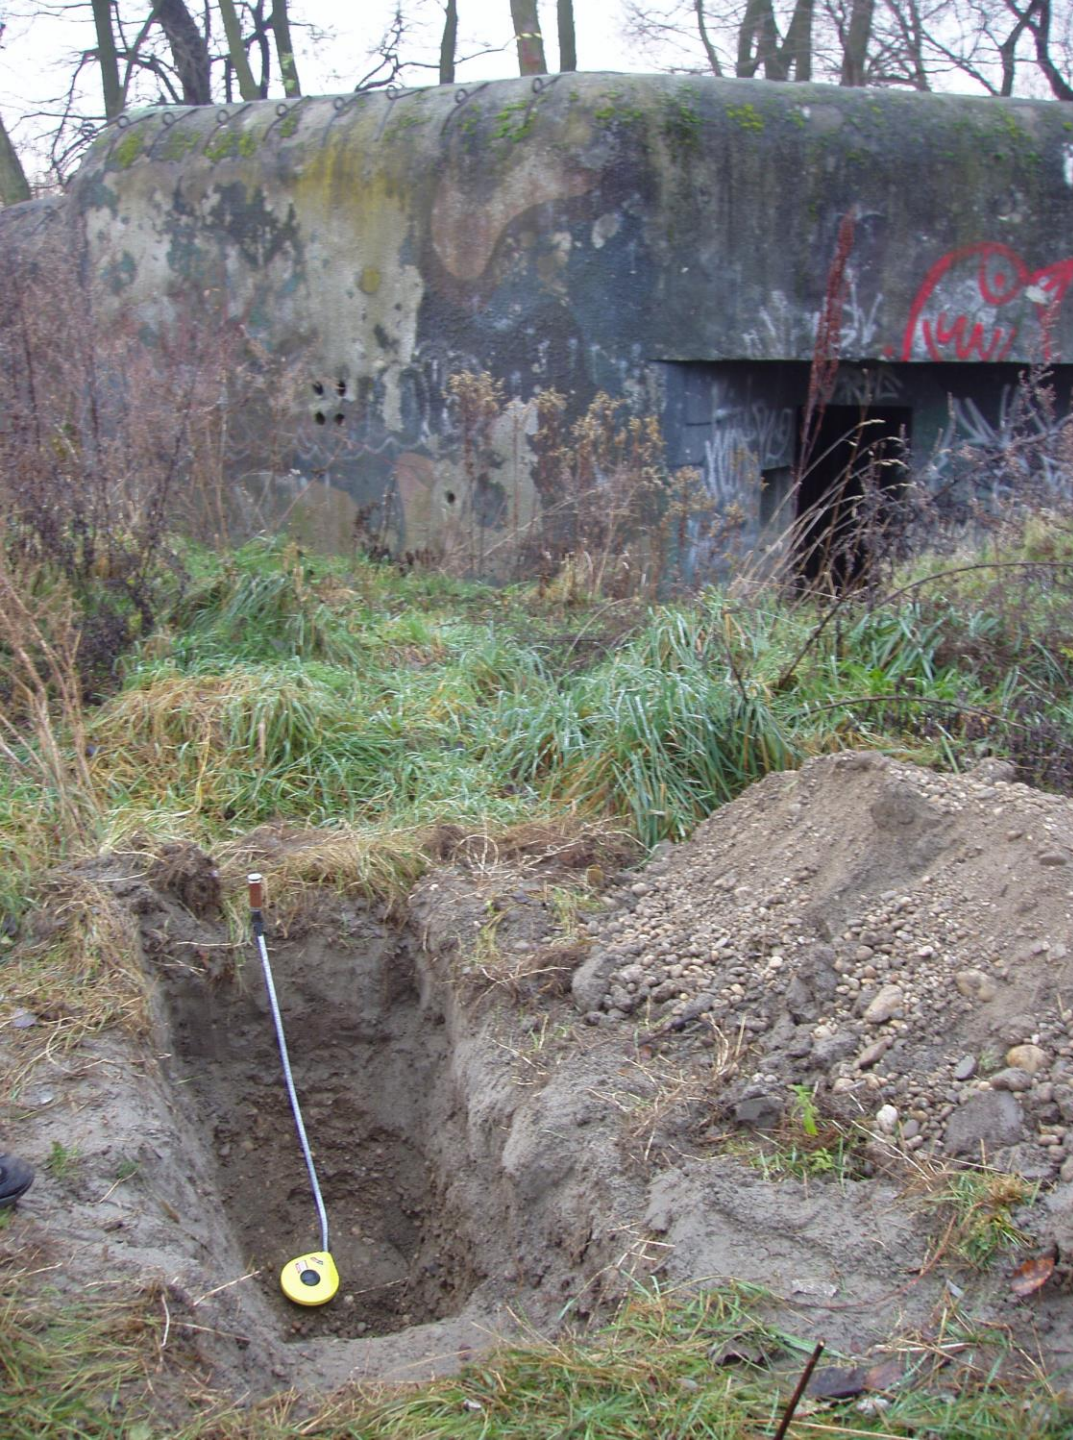
Bank profile

110 cm

170 cm

**More than 1 m of new
sediments after
construction (1 – 1,5
cm/year)**
