How a man changes the river (the Váh River in the 20th Century case study)

the Váh River story (some of the stories)

Ján Novotný

GEOGRAFICKÝ ÚSTAV SAV
INSTITUTE OF GEOGRAPHY SAS

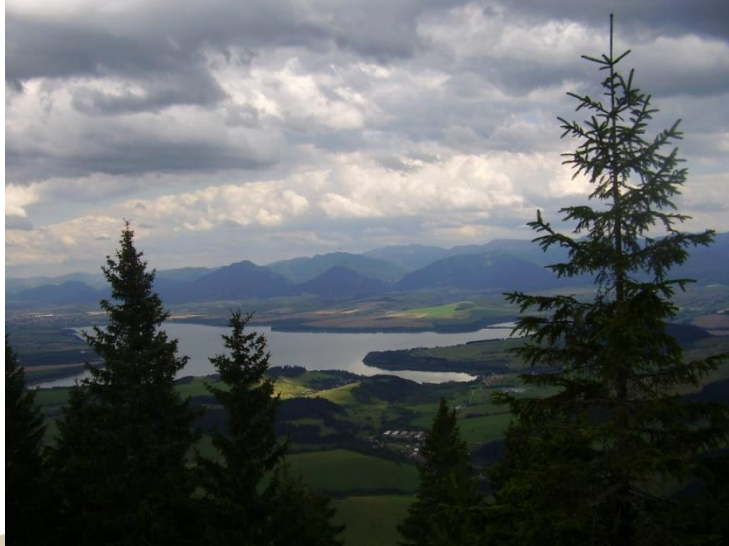
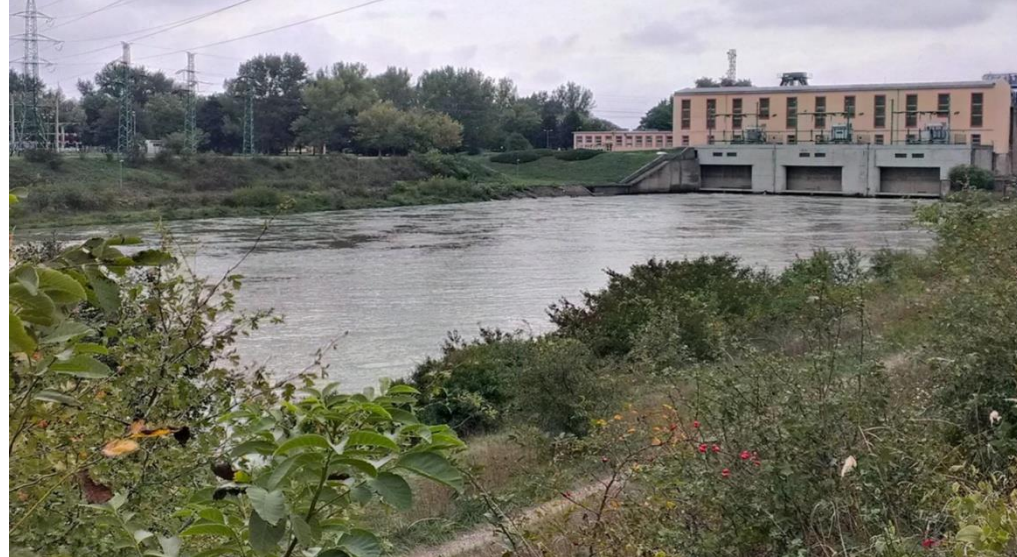
the Váh River

- first regulations at the beginning of the 19th Century
- construction of the “Váh Cascade” system in the 20th Century
- 22 dams and hydropower plants
- diverged (by-passed) channel reaches, total length of 140 km (more than 1/3 of whole river length)

segment	dam	by-pass	construction
1	Liptovská Mara + Bešeňová		1975 - 1976
2	Krpelianska priehrada		1957
3		Krpeliansky kanál	1957 - 1961
4			
5	VD Žilina		1994 - 1998
	Hričovská priehrada		1962 - 1964
6	Hričovská priehrada	Hričovský kanál	1962 - 1965
7	Nosická priehrada	Nosický kanál	1956 - 1958
8		Kočkovský kanál	1936 - 1949
9		Biskupický kanál	1953 - 1956
10		Biskupický kanál	1953 - 1956
	Sĺňava	Drahovský kanál	1960 - 1961
11	Kráľová		1985

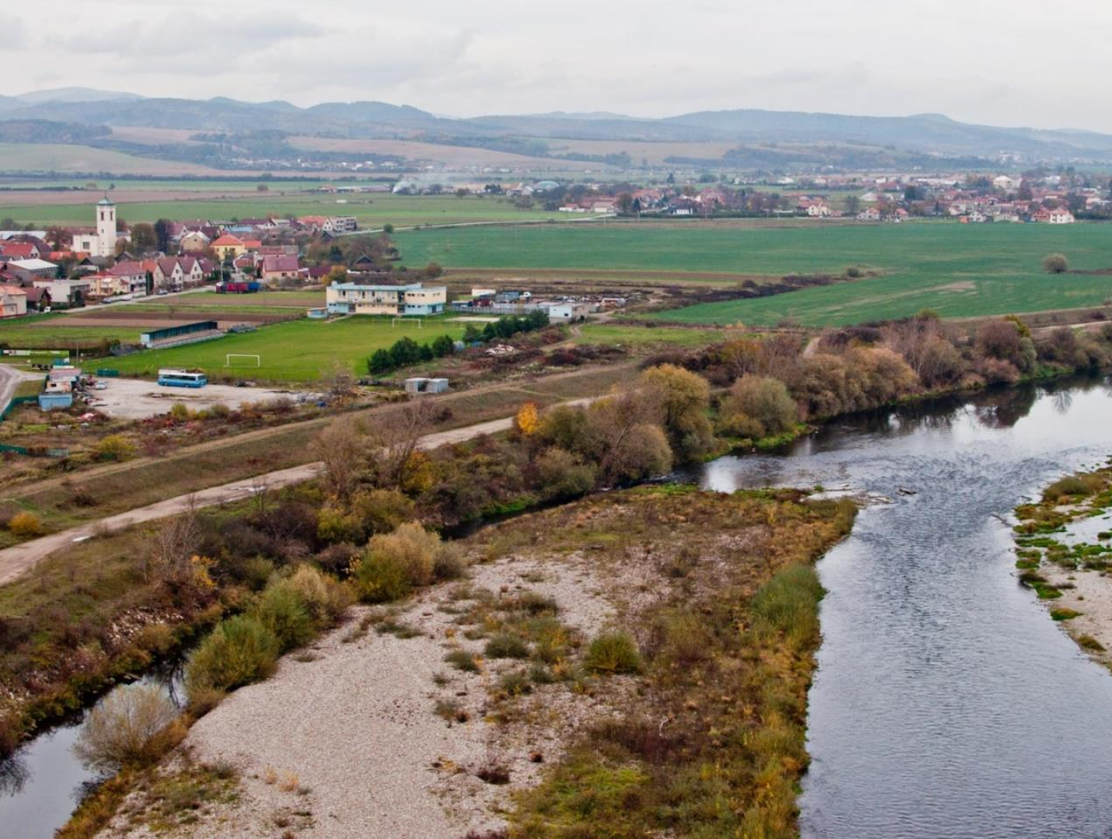
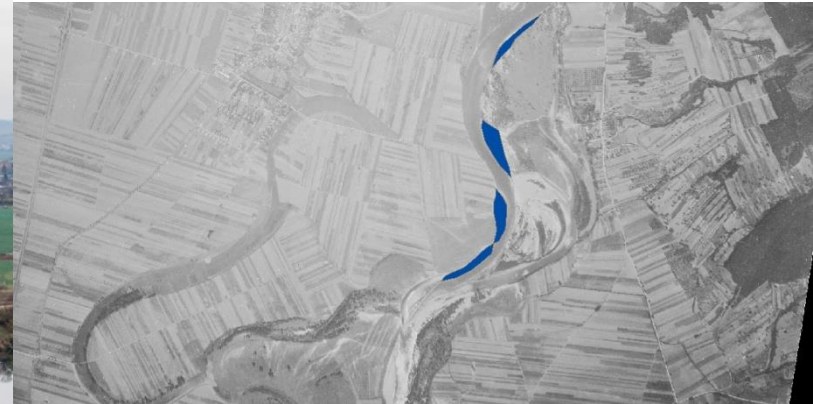
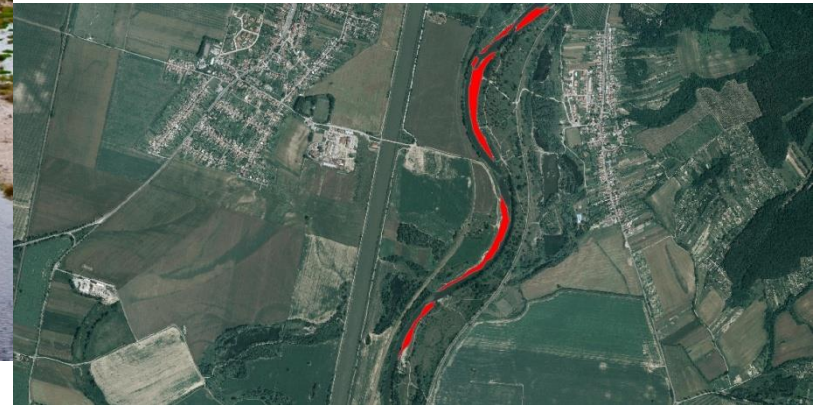
longitudinal connectivity within channel – channel bars evolution

channel bars localisation

- according number - ca. 40 % bars - overlapping in both time horizons
- according area - ca. 60 % - overlapping in both time horizons
- diminishing of smaller and stabilisation of larger bars

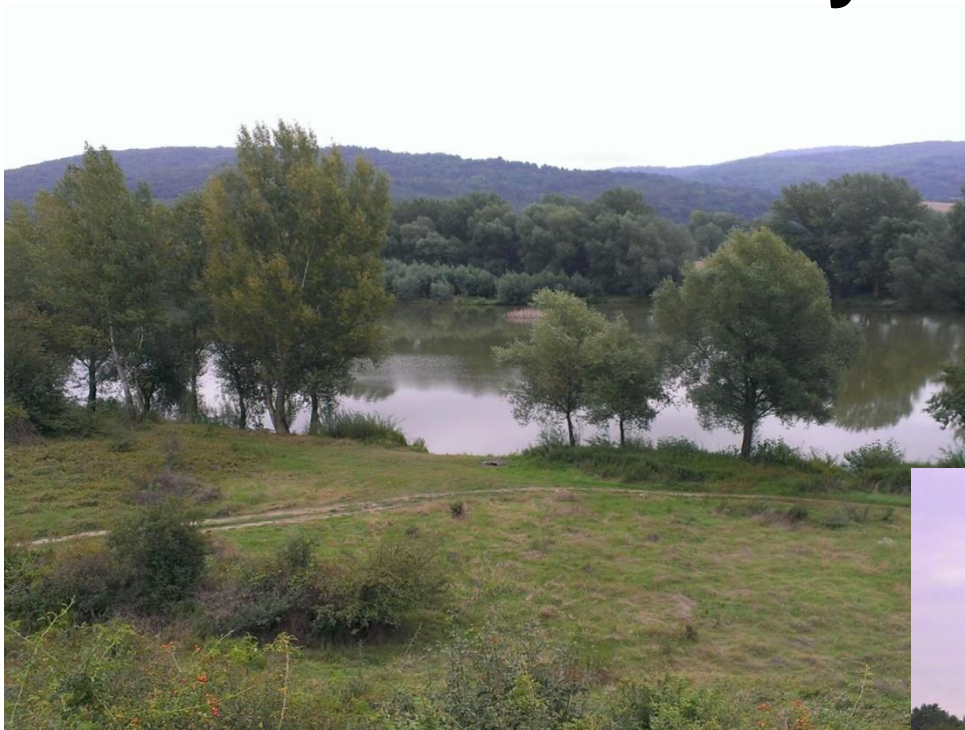
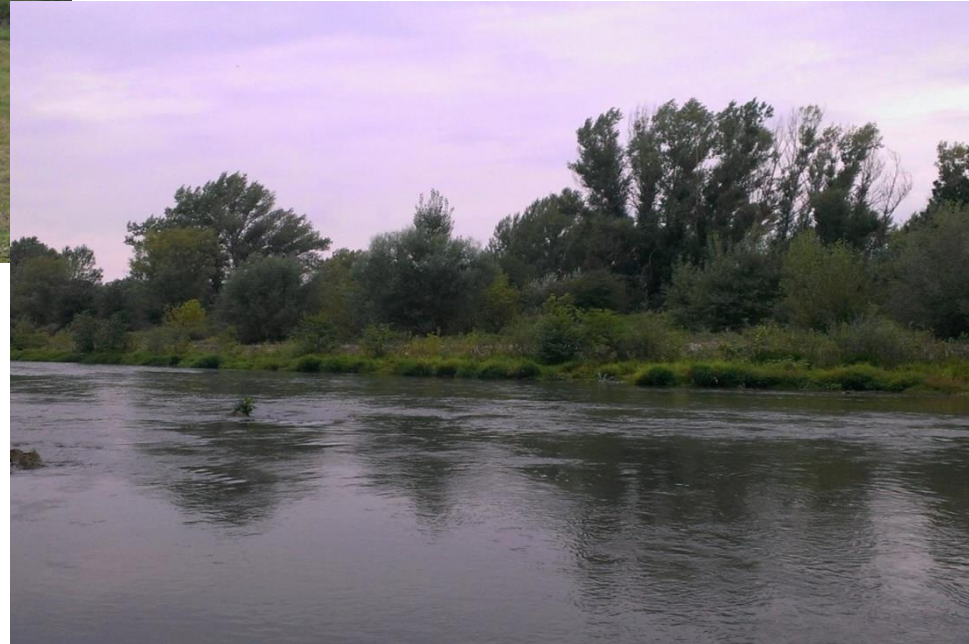
lateral connectivity – river banks analysis

Kráľova Lehota – Martin
